Subjects: Dock and Sea Trials "RTA 1" Catamaran Passenger Ferry
Metal Shark Franklin, LA.

The following was observed during my visit of April 27, 2018

First Catamaran Ferry "RTA 1"

Two (2) 32.0 (m) X 7.7 (m) X 1.35(m)RTA Passenger Ferries

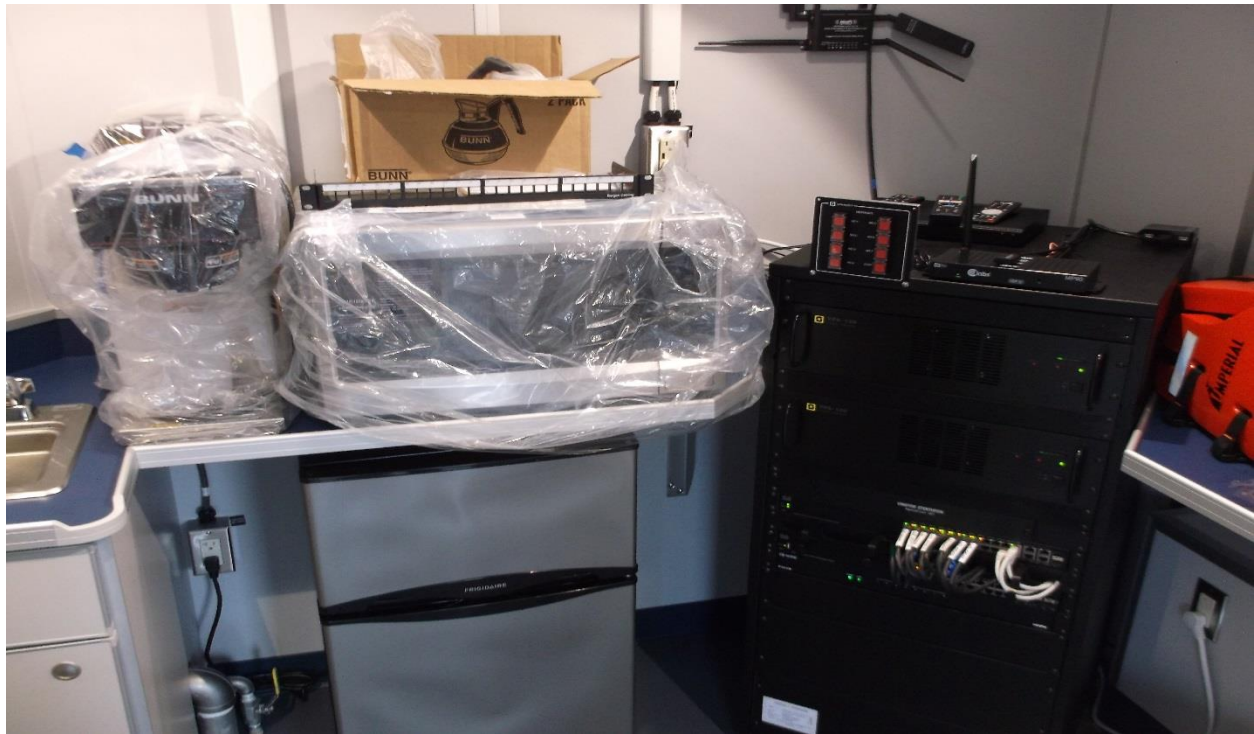
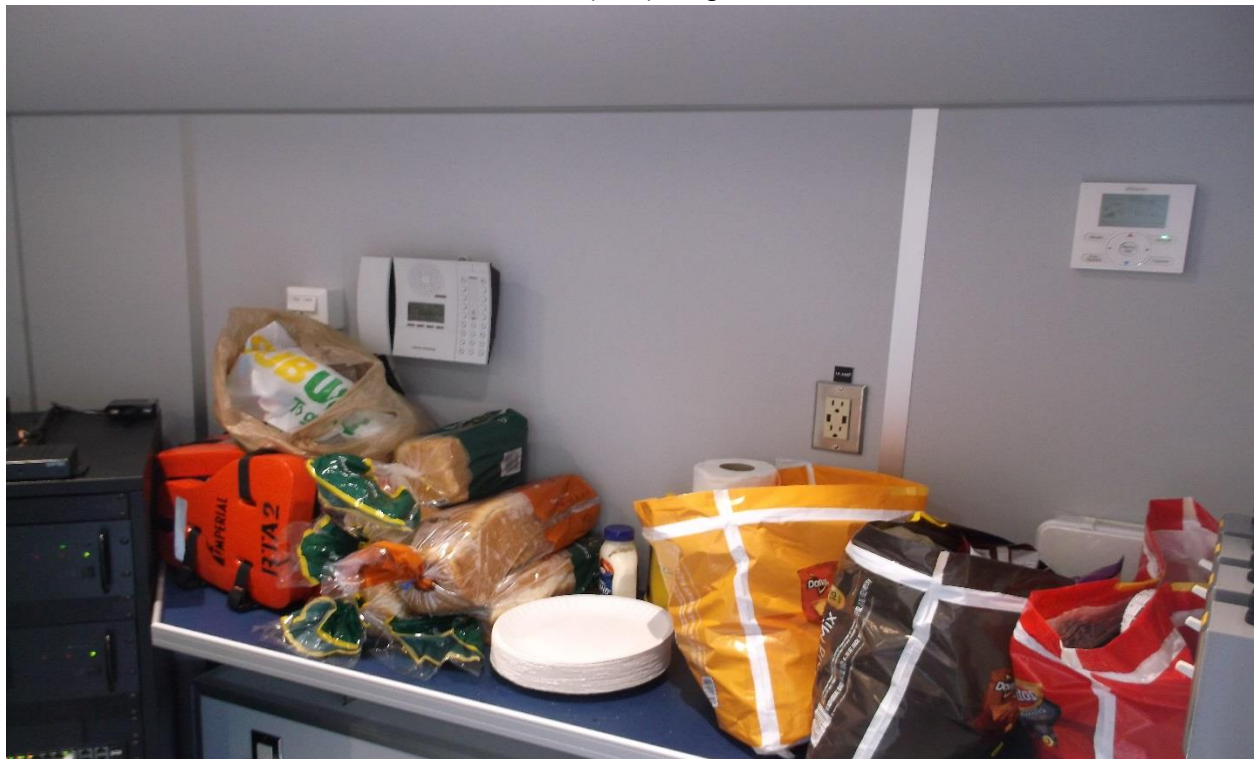
The crew office had the microwave and coffee maker on the counter top wrapped in plastic. The small refrigerator is on the floor operating but was found having both upper and lower doors dented appearing damaged. The circuit panel and lighting switches were labeled. The phone, wireless antenna and other various equipment were installed.

Views inside crew office (note) refrigerator doors dented

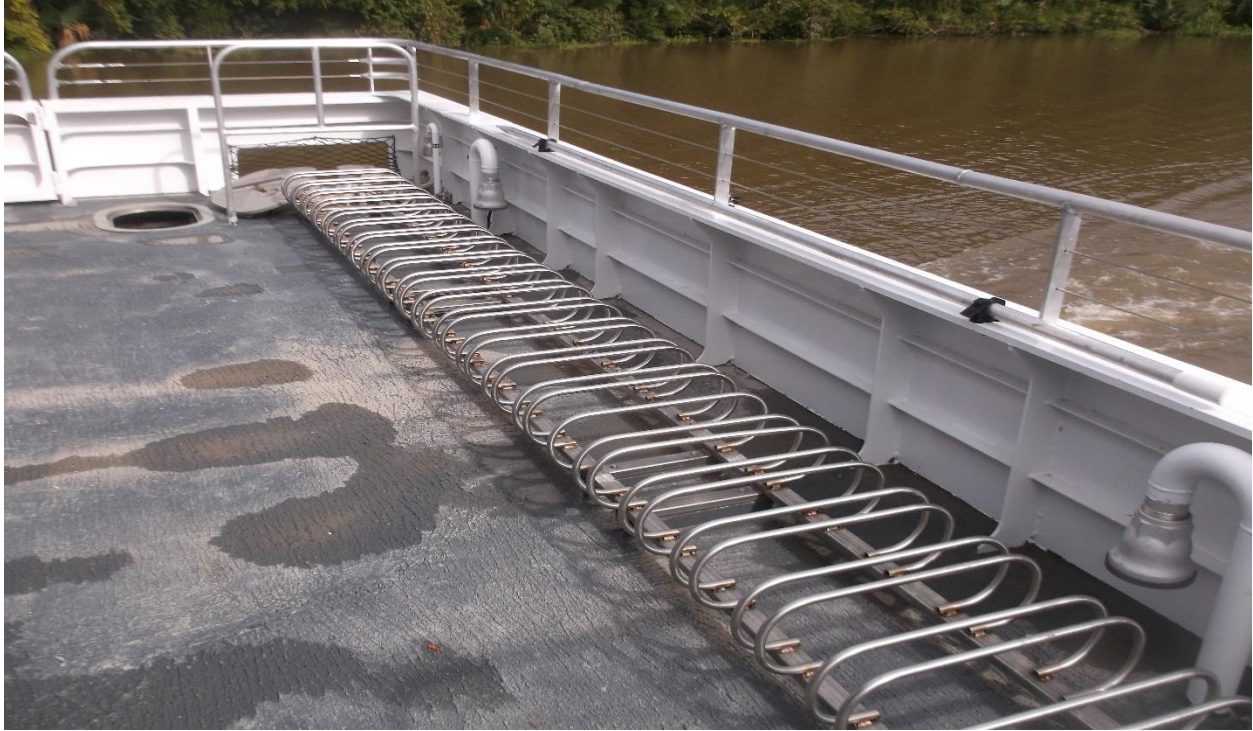
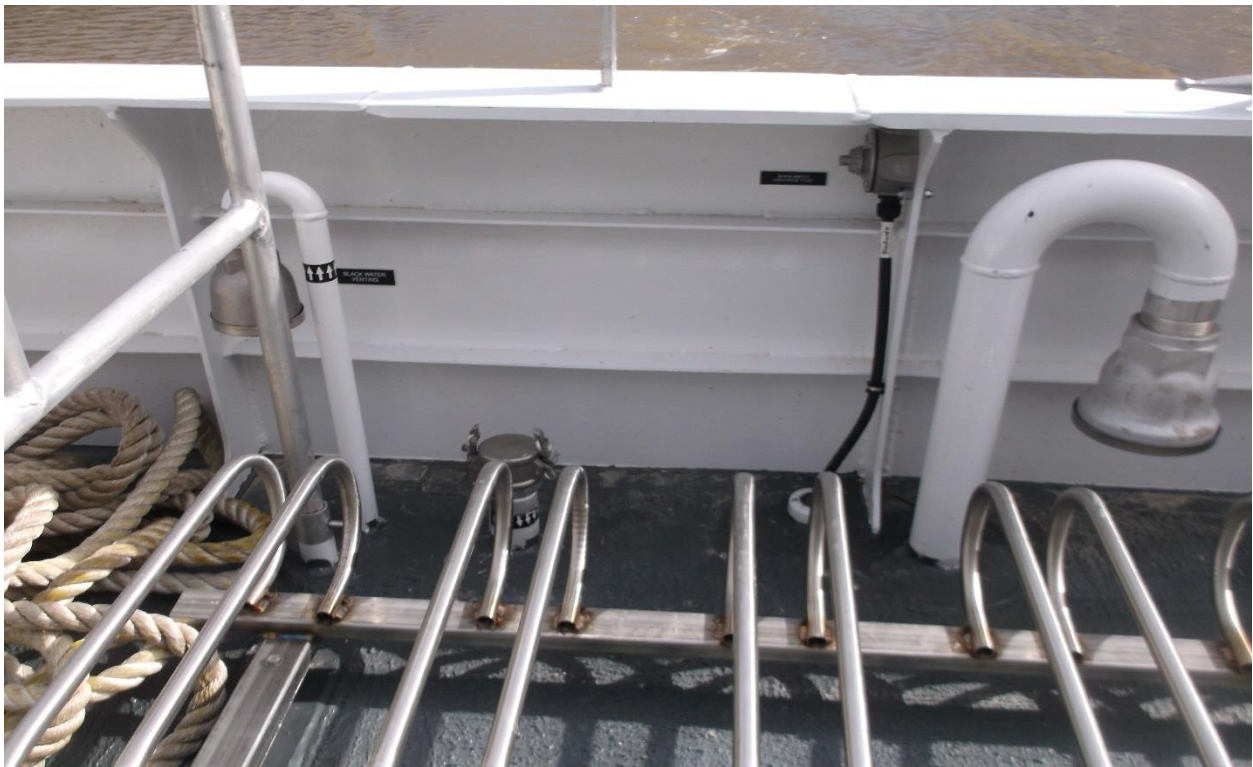
Aft stern views

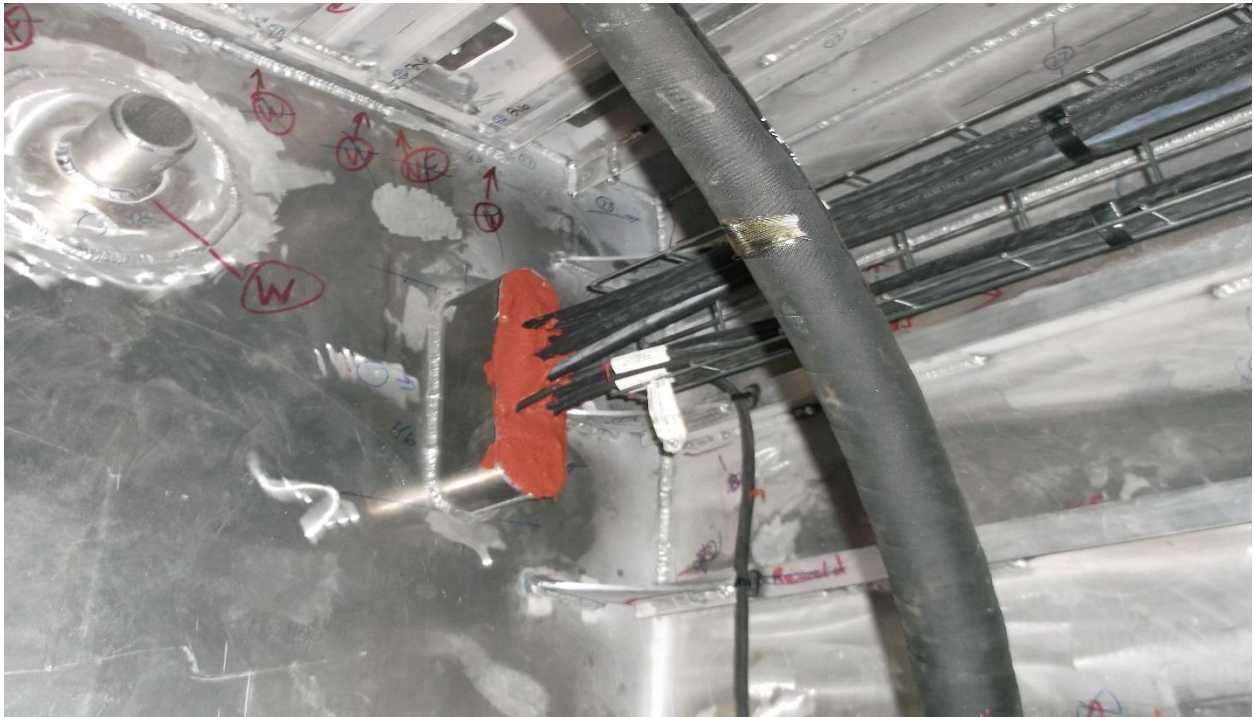
The foregoing hull voids were observed having fire block compound installed at all thru-bulkhead electrical cable passages. The fire block installation appears to seal openings and cables but is sloppily applied.

Views from various areas where fire block compound was sloppily applied to bulkhead passages

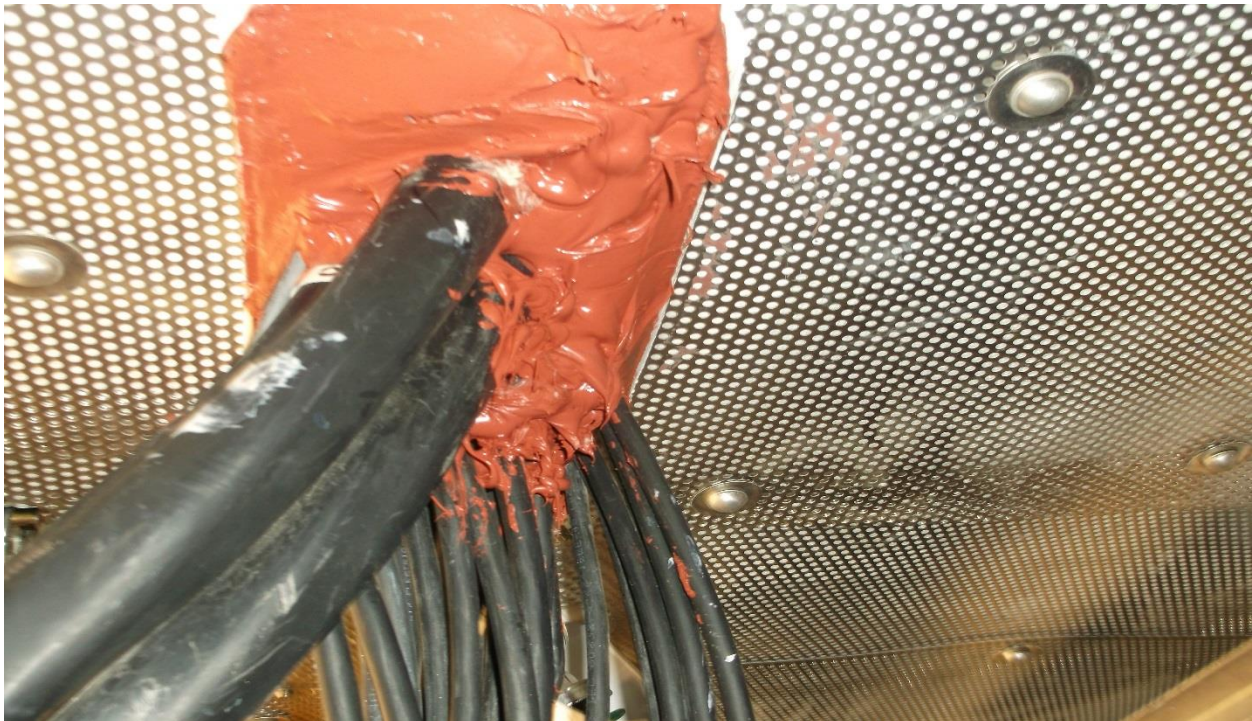
More view of fire block compound sloppily applied inside hull voids

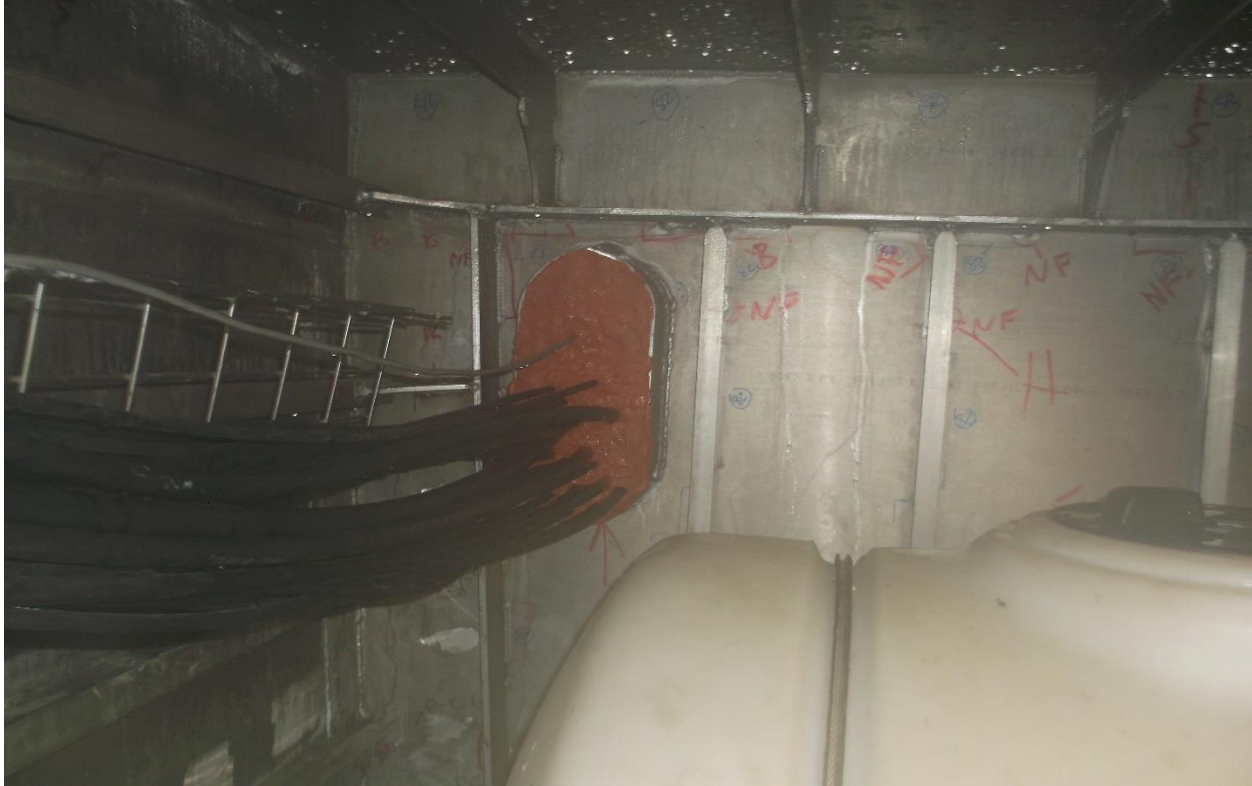
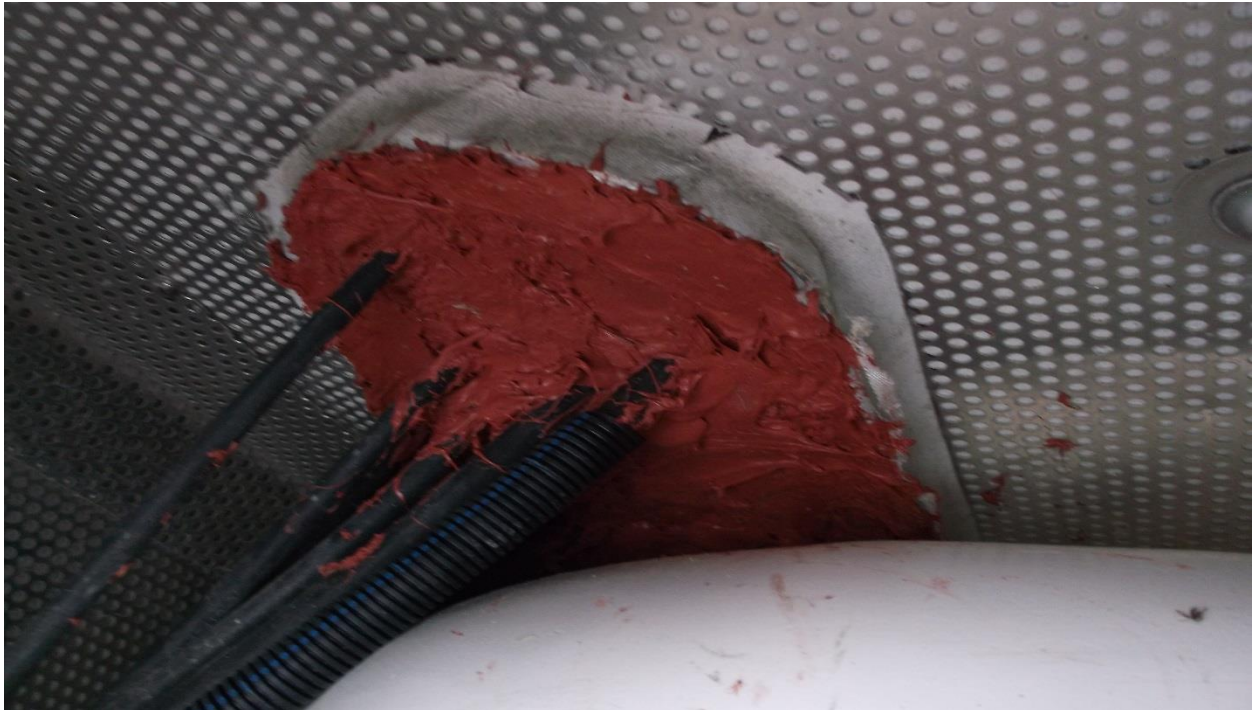
Fire block compound applied at bulkhead passages

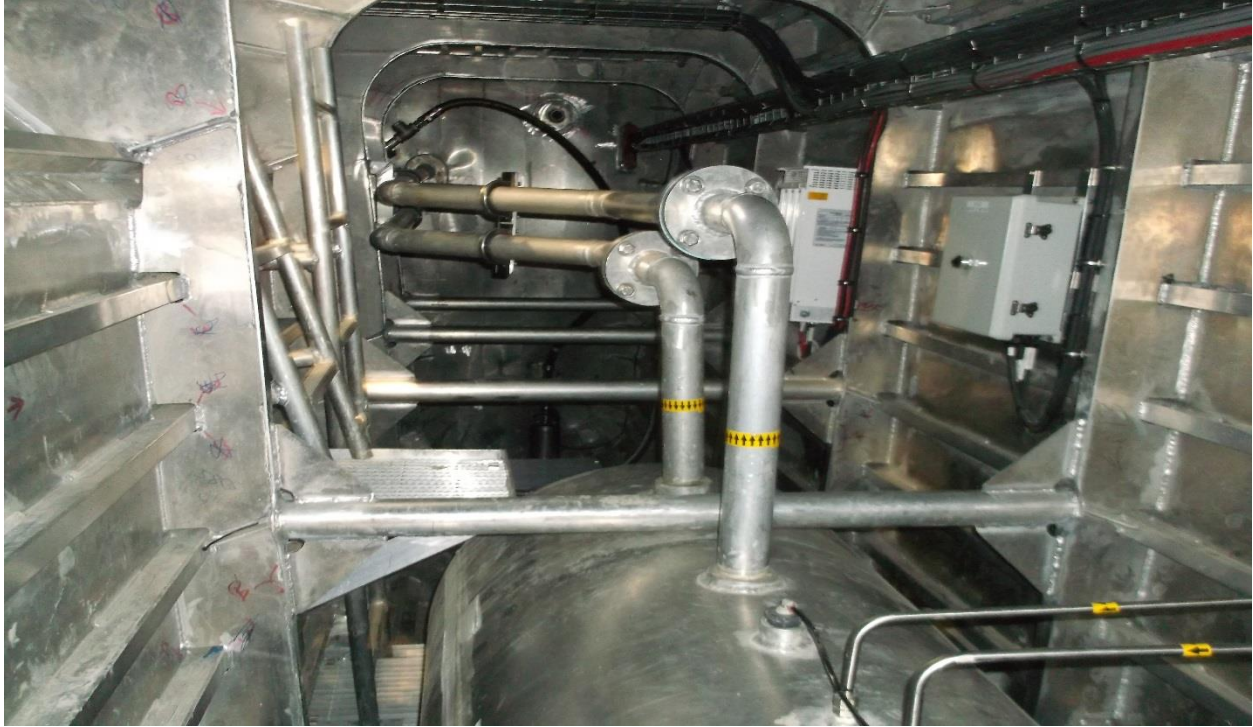
Typical view of fuel oil tanks and associated piping with bilge pump control and battery charge for machinery space

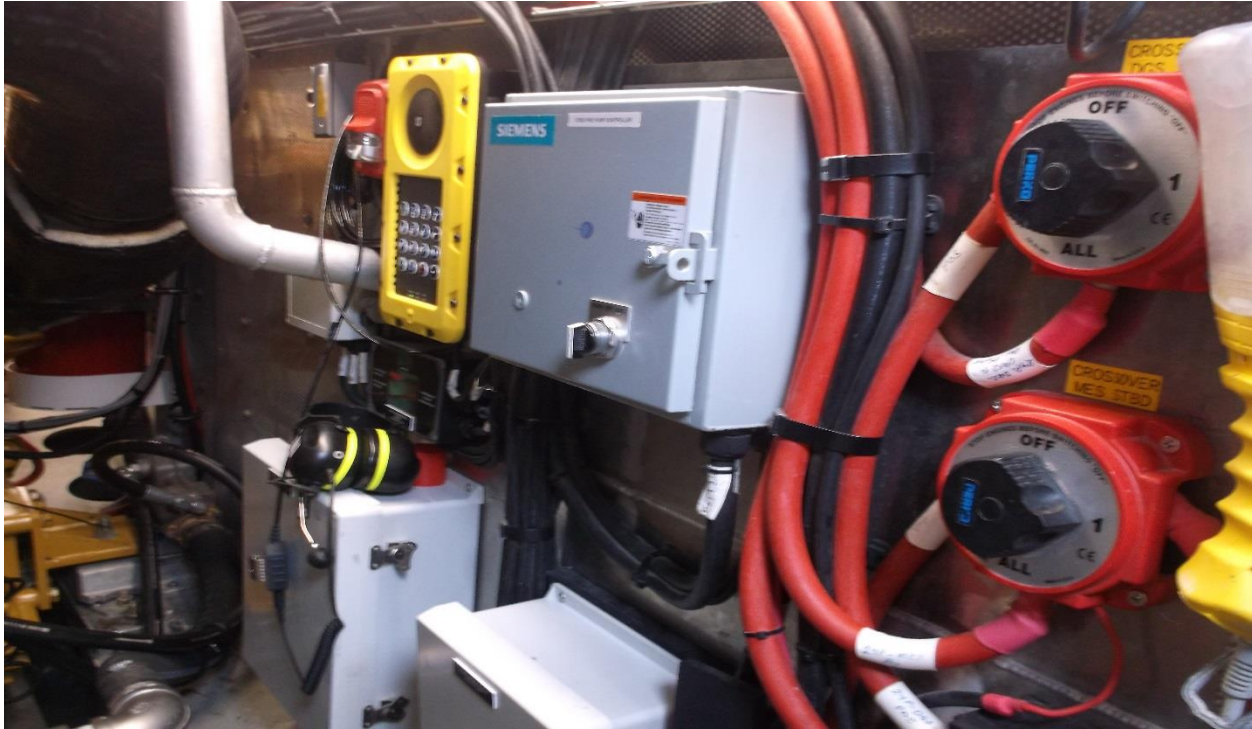
Views of battery crossover switches and other controls inside starboard machinery space

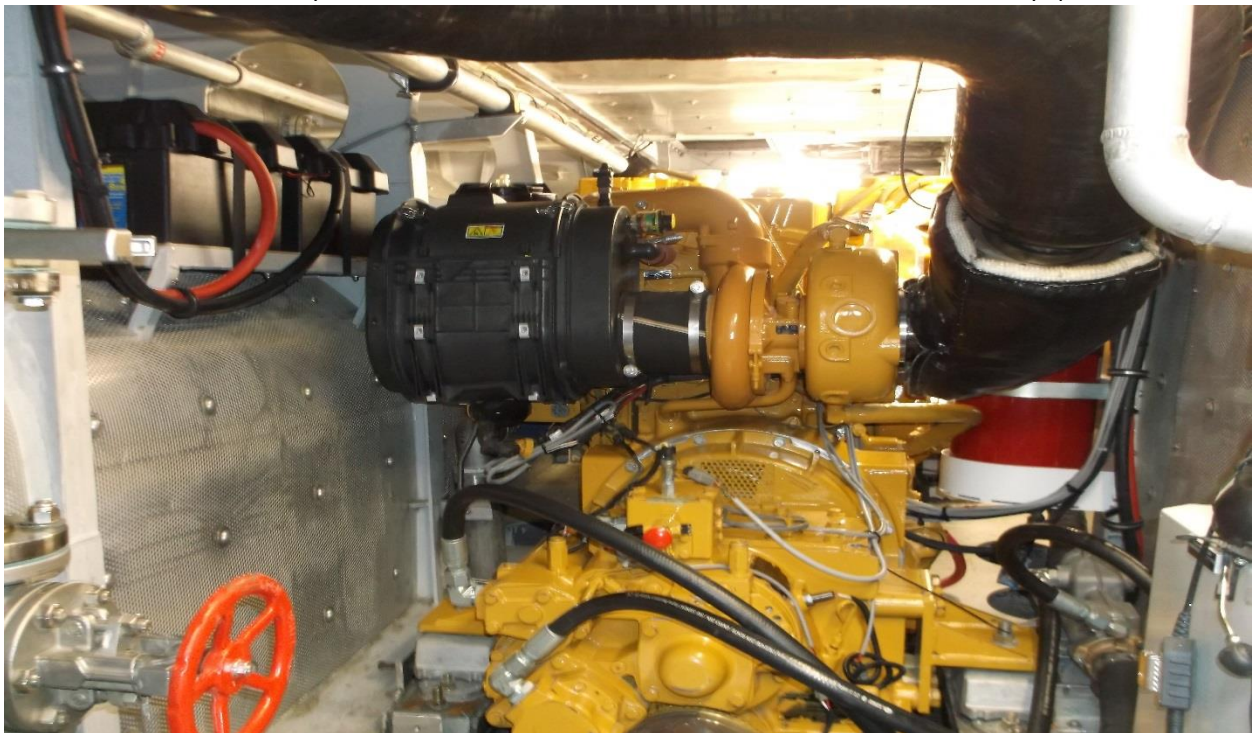
Aft view of starboard main engine

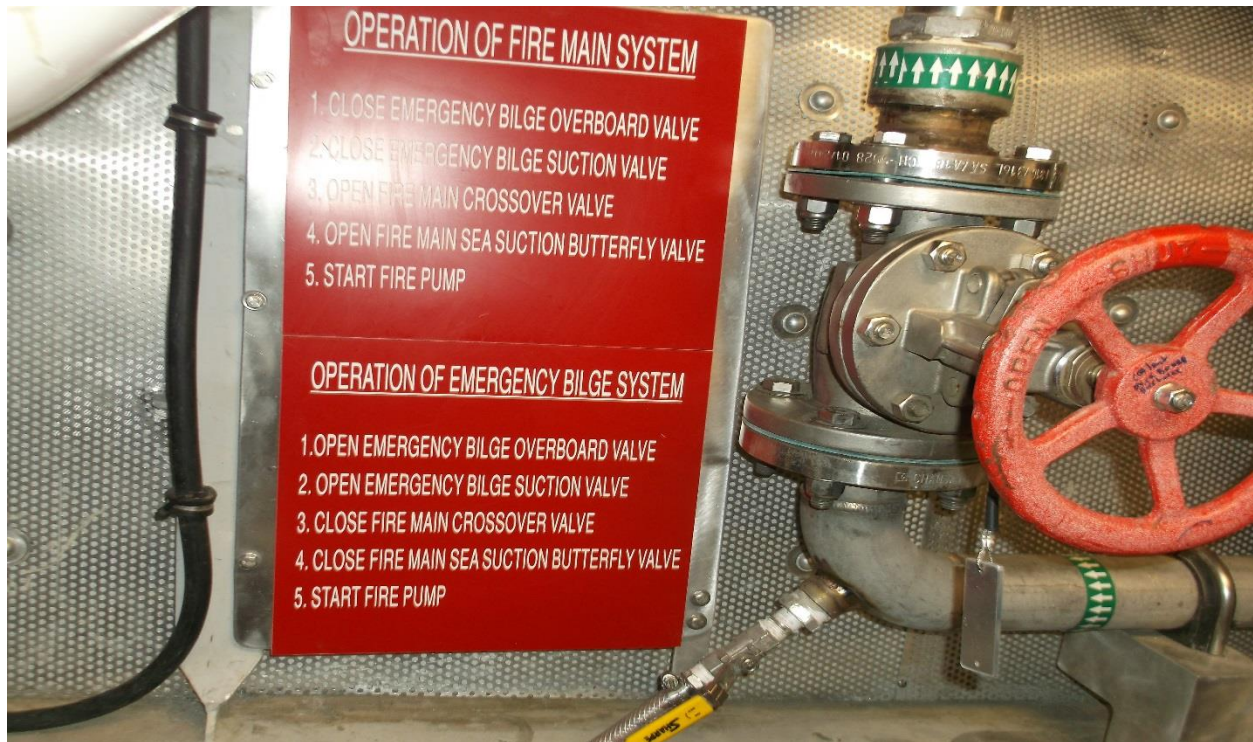
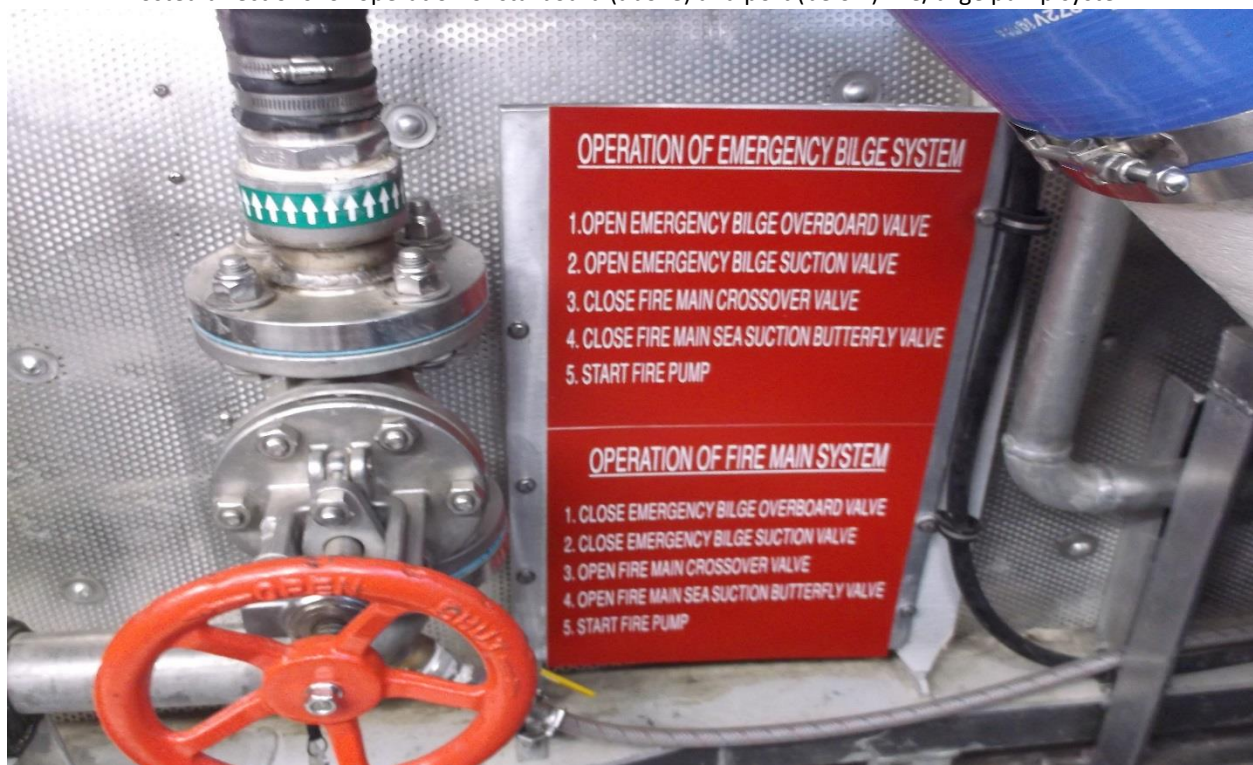
Posted directions for operation of starboard (above) and port (below) fire/bilge pump system

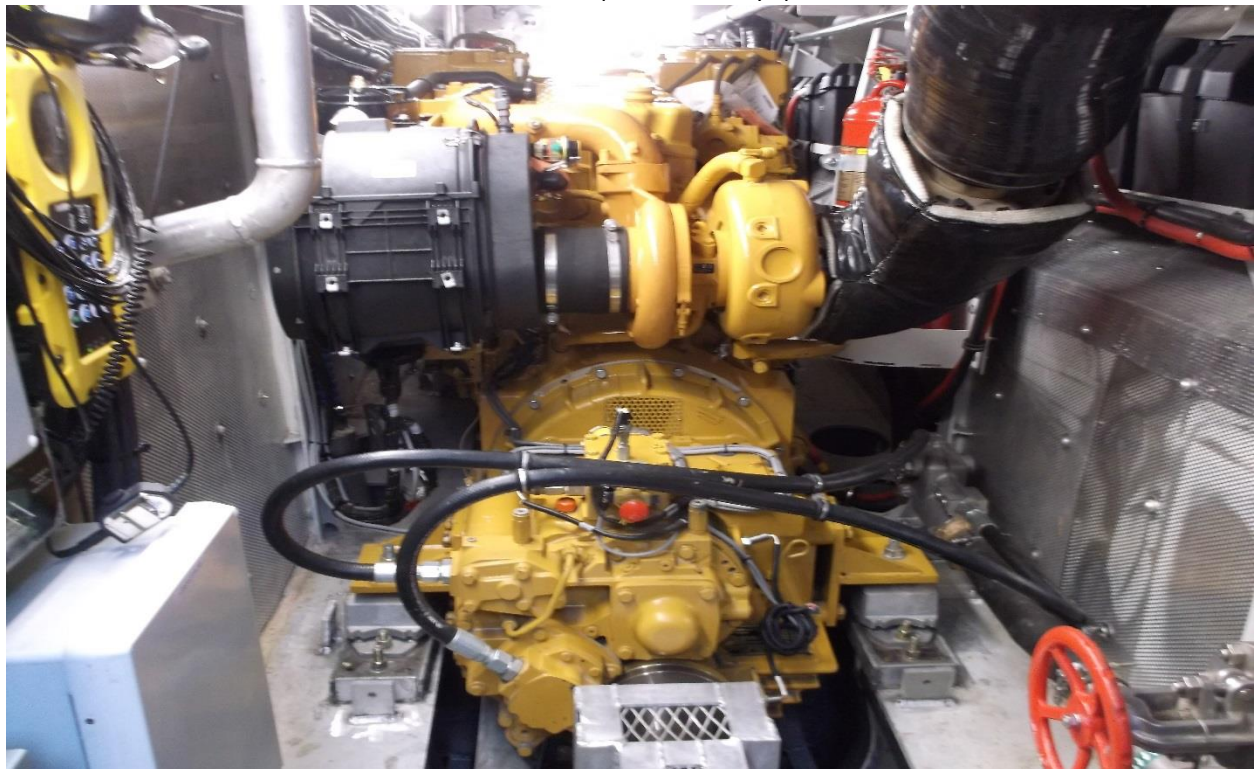
Views inside aft port machinery space

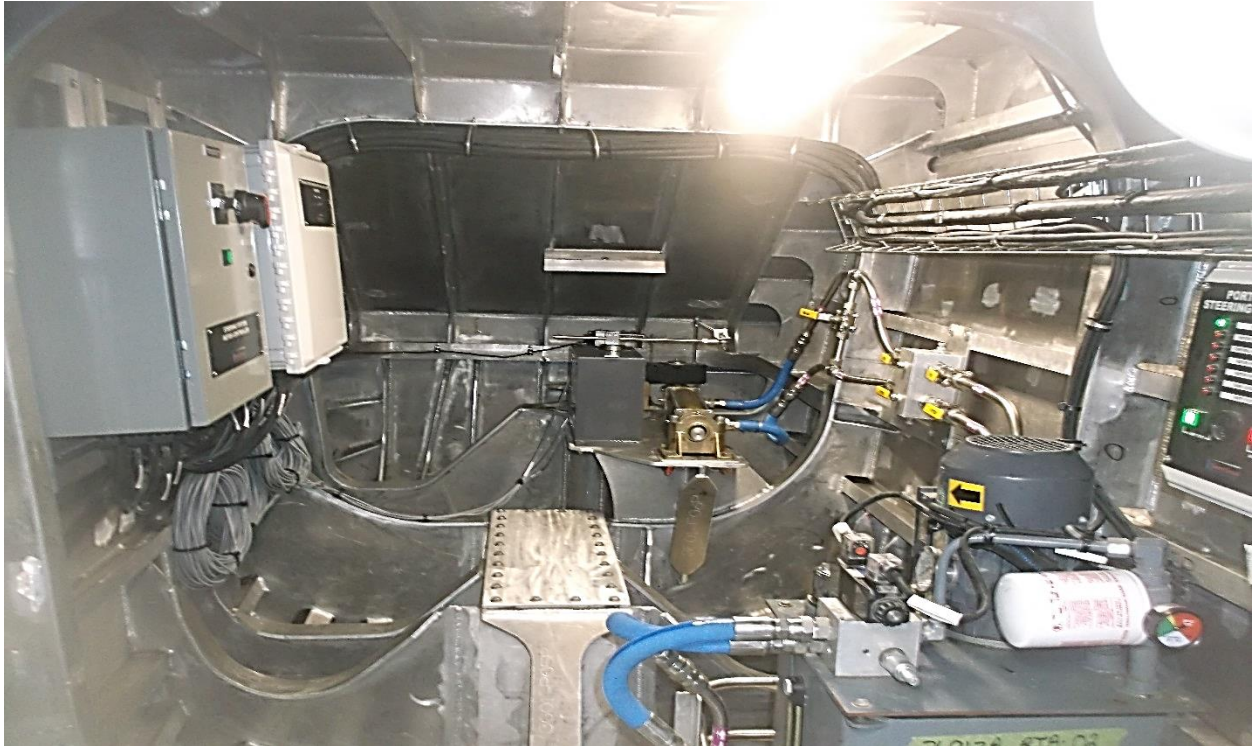
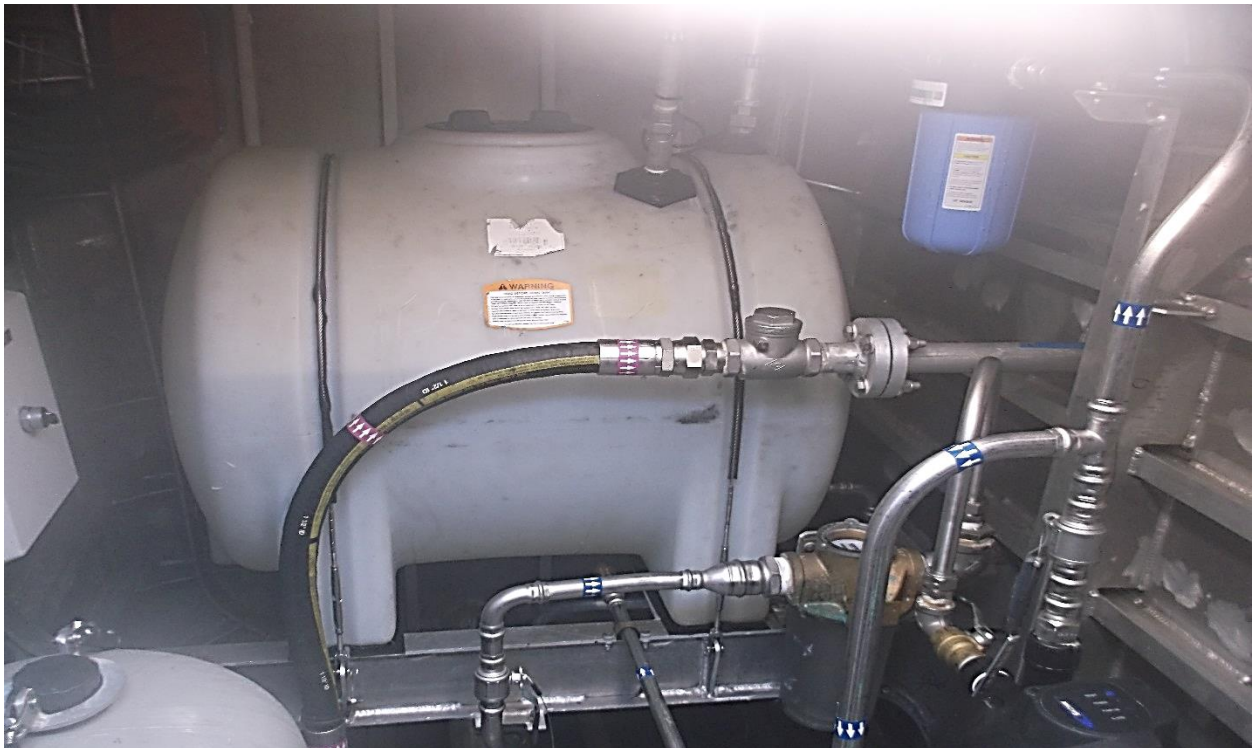
Number 5 hull steering gear and potable water and gray water tank voids with associated equipment were observed having controls/monitoring panels in working order and appropriately labeled. Each void has lighting and small air circulation fans.

Views inside port no.5 hull steering/potable water tank void

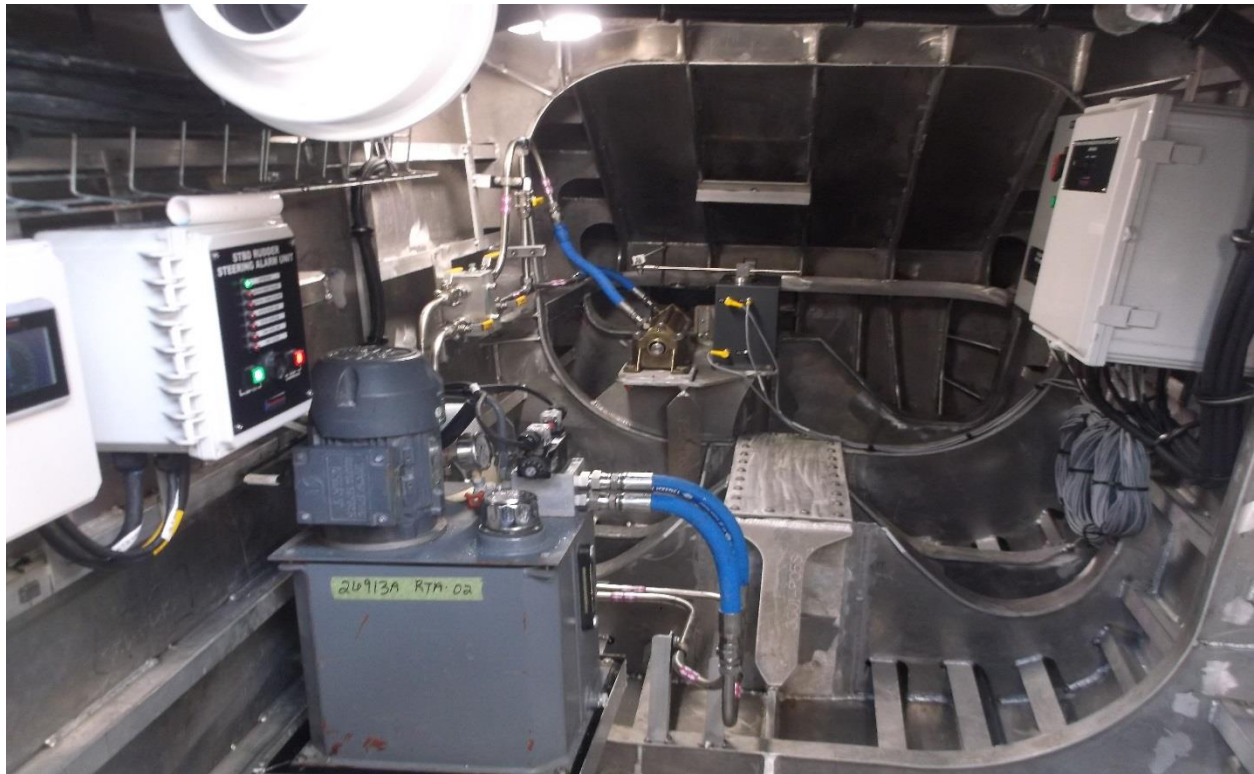
Views inside no.5 starboard steering equipment and MSD (gray water) tank and system

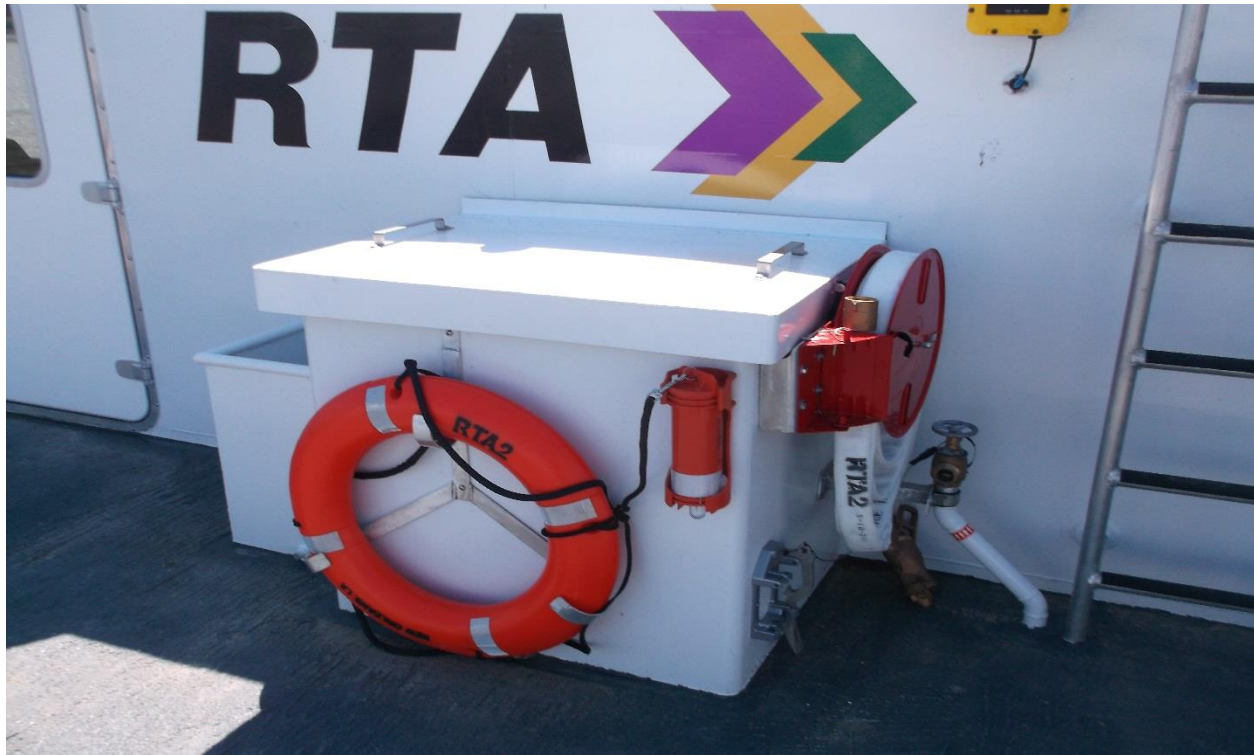
The forward main deck was observed with fuel oil containment filling caps for each tank with associated goose neck vent and flame screens. A weather cover is installed over fuel oil containment with rubber side mounts. There was approximately 8" of rain water to remove from containment. The anchor, chain and rope were stored onto the bow along with mooring line retrieval poles located on the bow and stern ends.

Views of fuel oil containment area with weather cover and lower view inside having water within

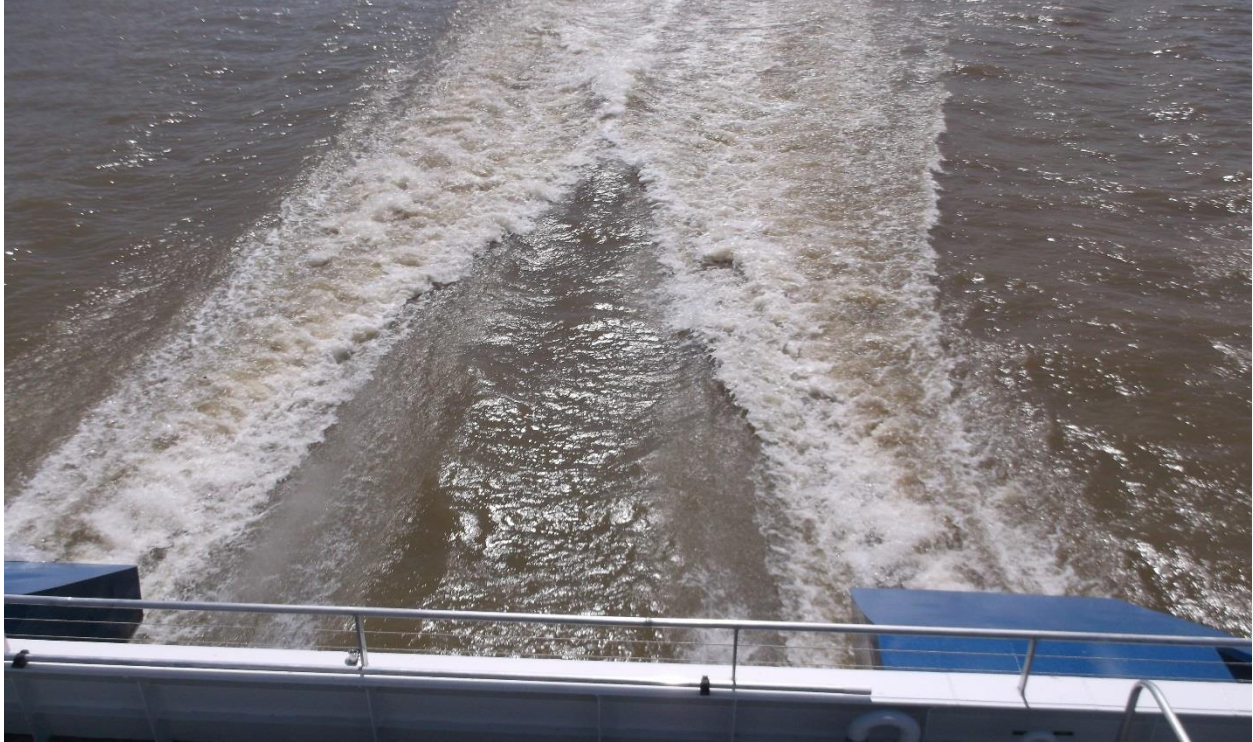
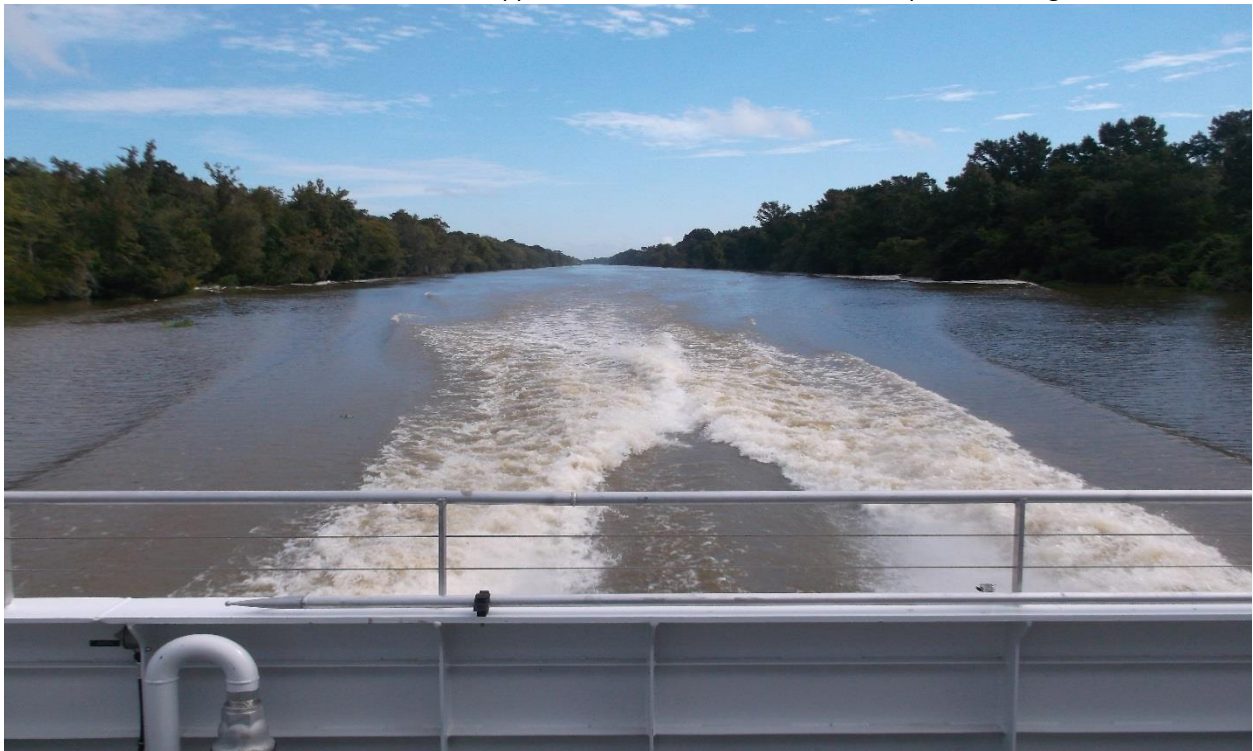
Views of vessel wake from upper deck and stern end as vessel is up and running
